Pentium[®] II Processor Specification Update

Release Date: March 11, 1998

Order Number: 243337-012

The Pentium[®] II processor may contain design defects or errors known as errata which may cause the product to deviate from published specifications. Current characterized errata are documented in this Specification Update.

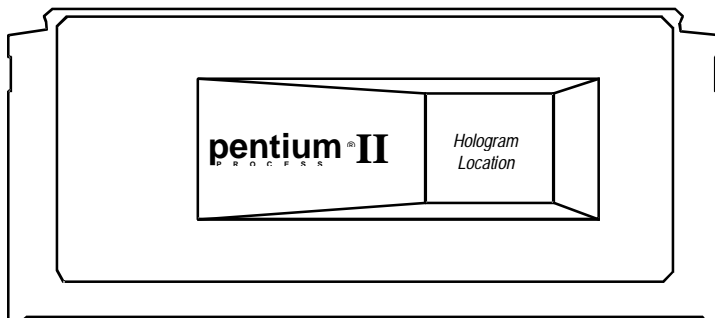
2-D Matrix Mark
Intel UCC#
Order Code (Product - speed)
S Number
Lot Number (date, factory)

- ZZZ = Speed (MHz).
- SYYYY = S-spec Number.
- LLL = Level 2 Cache Size (in Kilobytes).
- FFFFFFFF = FPO # (Test Lot Traceability #).
- XXXX = Serialization Code.

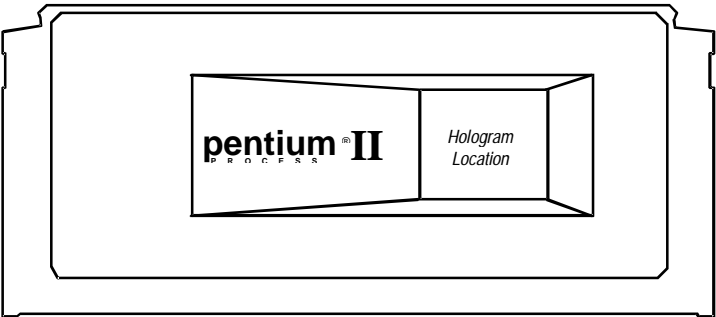
dA-Step Production Units

B80523PZZZLLLE SYYYYY 2.0V
FFFFFFFF-XXXX Country of Origin

- ZZZ = Speed (MHz).
- LLL = Level 2 Cache Size (in Kilobytes).
- E = ECC Support in Level 2 Cache
- SYYYYY = S-spec Number.
- FFFFFFFFF = FPO # (Test Lot Traceability #).
- XXXX = Serialization Code.

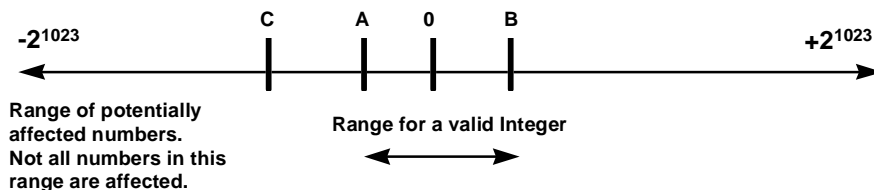
IMPLICATION: Erroneous operation results when the operand is so large that it will not fit into the target data size. The operands affected by this erratum are significantly outside (by a factor of 3X) the range that can be, correctly, converted to an integer value. The figure below and corresponding table identifies the normal range of integer numbers (between A and B) and the starting point of the operands affected by this erratum. Discrete failing operands will be present in the range between point C and the maximum negative number that can be represented by the processor (-2^{1023} in double precision format). Note 2 below gives a qualitative description of the nature of the discrete failing values. Software that does not rely on the Invalid Operation exception flag being set and signaled by either an exception OR by software polling is not impacted by this erratum.

16-bit Operation	A	B	C
	-32,768.0	+32,767.0	< -98304.0
32-bit Operation	A	B	C
	-2,147,483,648.0	+2,147,483,647.0	< -6,442,450,944.0
